September 12, 2018

Re: Suzuki property preliminary tree assessment, Bainbridge Island, WA

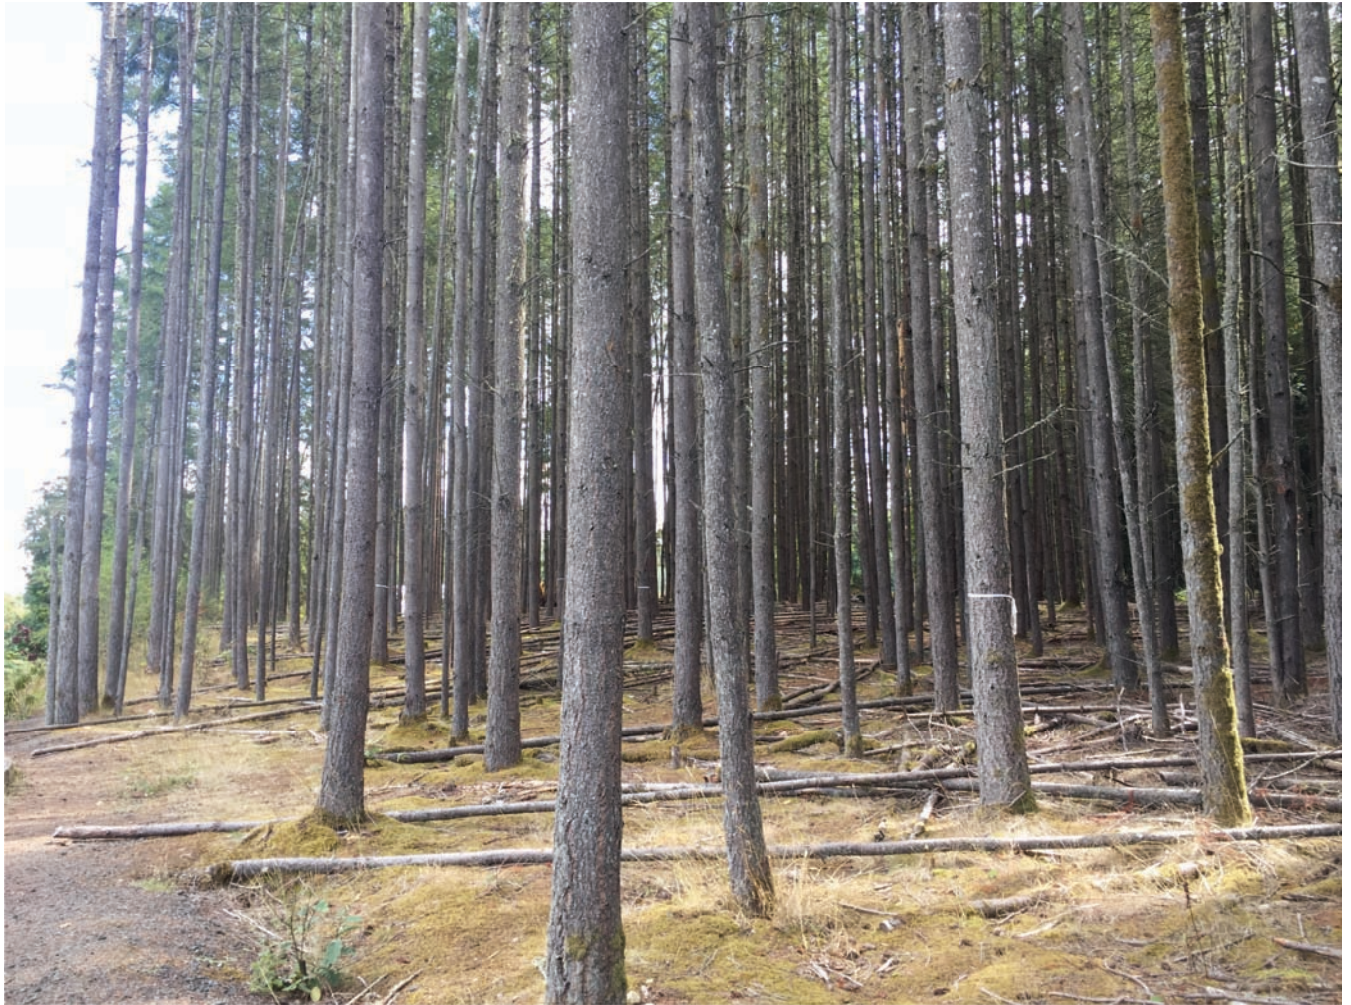
the north property line as well as a good portion of the northeastern proposed development area (Photo 1).

The fir trees originally were planted in a dense array typical for forestry purposes and then left unmanaged. Many standing small dead trees are leaning against living trees and fallen trees litter the ground. Except in a small portion of the center of the north property line there is little to no groundcover vegetation between tree stems.

Trees in the sample area and along the northern property line as a whole are in poor to fair condition. Since they have grown so close together most of the trees will not have strong or wide growing root zones. Also, most of the trees have a very small live crown ratio, that is, the amount of living green foliage growing on the stem. All of the living foliage is growing at the very top of each stem.

Retaining single or even small groups of trees in this area and expecting them to remain windfirm would be an incorrect assumption. If any single tree in this area was exposed by clearing around it it would have a high potential of blowing over. Exposed small groups of trees would also suddenly have a high potential of root failure that could impact the surrounding area for several years after being exposed. I strongly recommend that the fir trees in the sample area and those along the northern property line be considered for removal. Replanting the area in which they grow can distinctly improve this portion of vegetation along the northern property border to provide a healthier vegetated buffer area between the new development and New Brooklyn Road.

Photo 1: Trees shown in this photo are representative of Area 1 trees growing along the north property line. Those taped in white are the only that measured greater than ten inches.

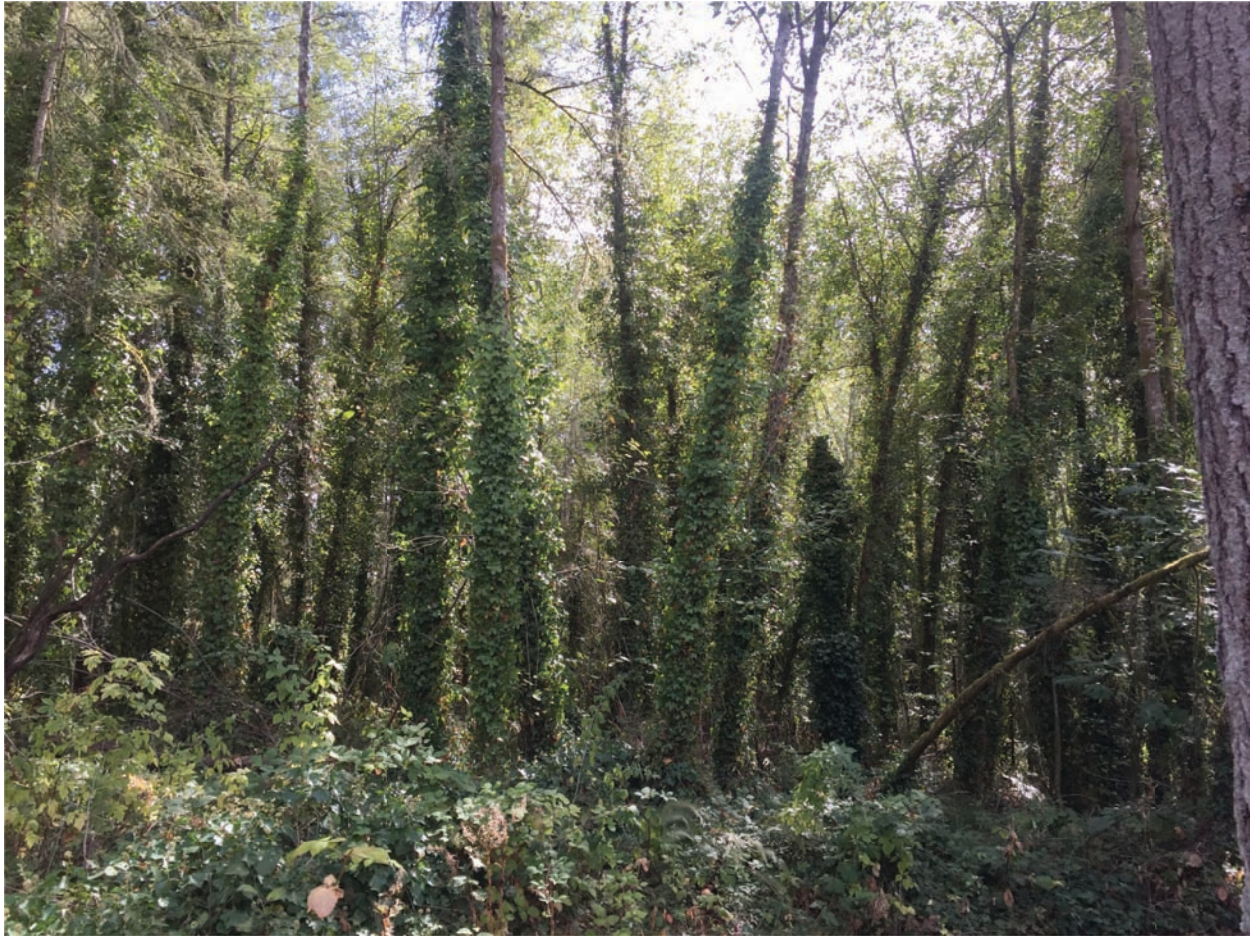
The northwestern portion of the property has a few sporadically planted Douglas-fir similar to those mentioned above but is primarily dominated by numerous red alder (*Alnus rubra*) trees. Most of them have thick English ivy growing up a good portion of their trunks and covering the ground around their bases (Photo 2). The extent of the ivy on the ground and growing up trees reaches west to trees standing near the walking path and to the south approximately one third down the western property line.

Most of the alders in this area are only in fair condition. None of them have very straight trunks and few have more than 30 percent live crown. Although younger in age none will develop into windfirm straight trees and will be particularly vulnerable to weather conditions if exposed by nearby clearing.

Photo 2: Area 2 – red alder trees covered in English ivy.

Removing the ivy from this area would significantly improve the landscape and reduce the possibility of trees being pulled over by ivy weight. However, removing ivy from the trees and the landscape would be an endeavor difficult to accomplish by machinery without damaging root and trunks of trees already only in fair condition. Work to remove ivy by hand would be less damaging but a large undertaking that could ultimately take several years to achieve.

It is my opinion that it is more feasible and better in the long term to remove the alders and ivy and to replant the area with a dense mix of native deciduous and evergreen tree and shrub species.
