SUZUKI PROPERTY ECOLOGICAL ASSESSMENT

Bainbridge Island, Washington

March 2017

City of Bainbridge Island

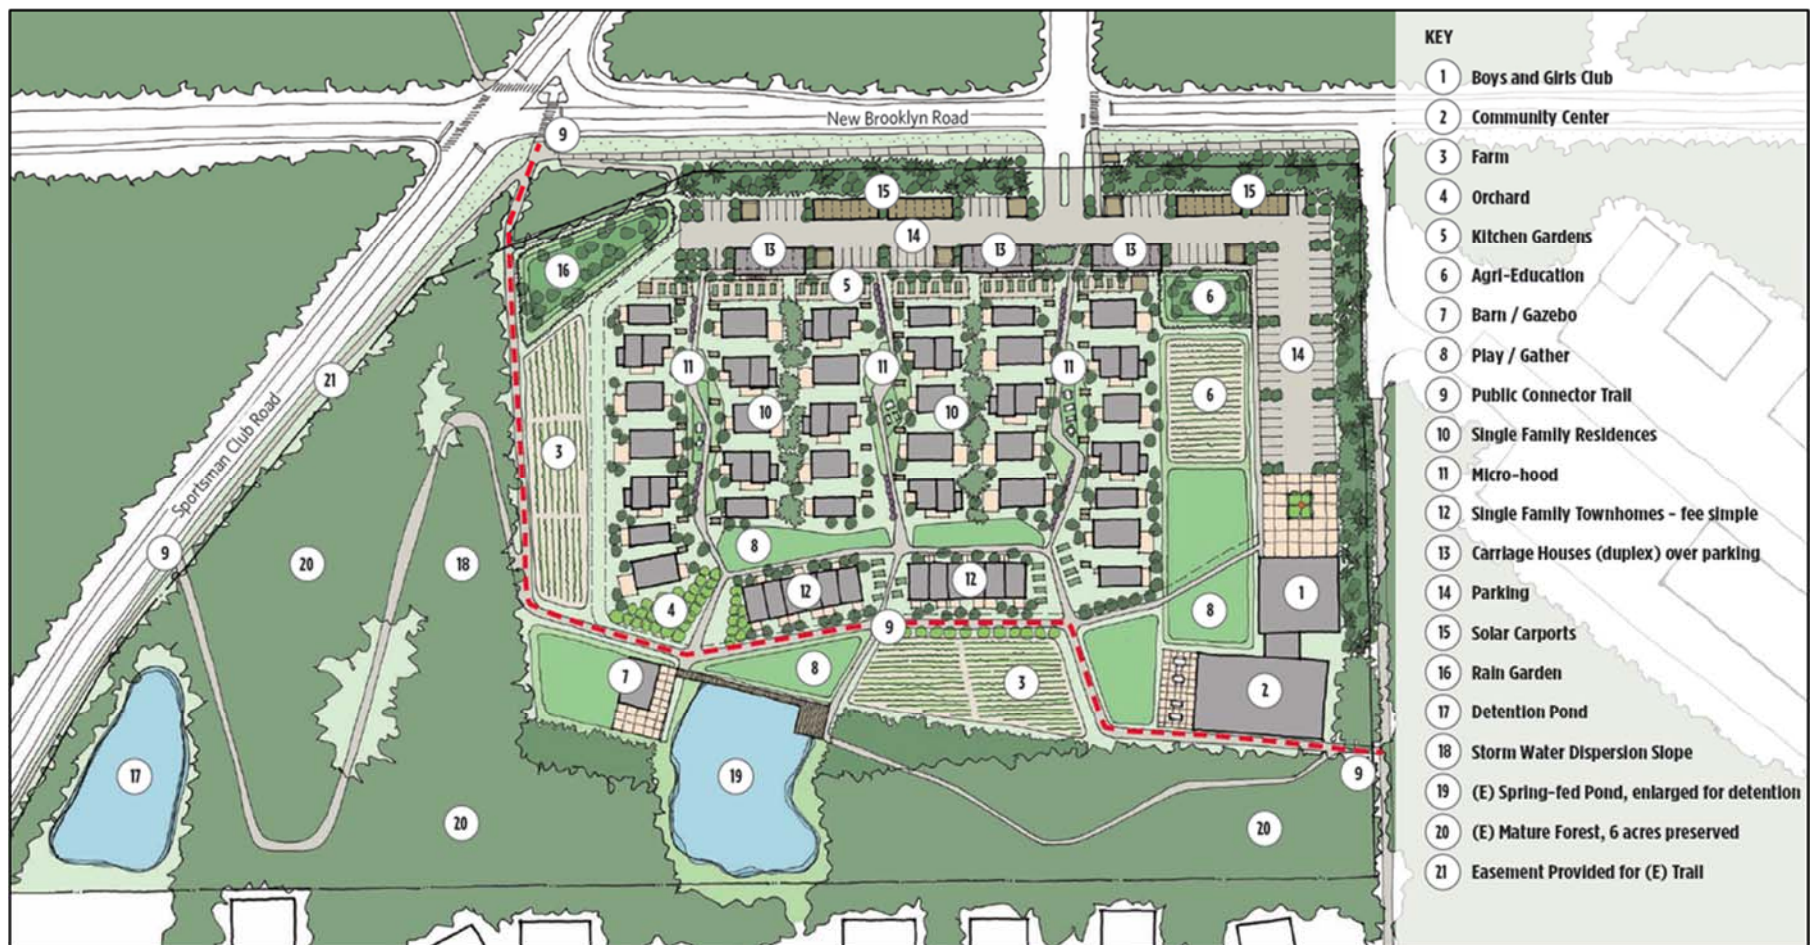
Figure 2
Olympic Property Group "Suzuki Farm" Development Concept

The City received four RFP submissions, and in March 2016 the City Council selected the Olympic Property Group (OPG) proposal. The development concept presented in the OPG proposal is called the “Suzuki Farm,” and includes affordable housing, a community center, community gardens and orchards, open space preservation, and trails (Figure 2). The proposed concept shows the development concentrated in the northeastern portion of the property, while preserving the remainder of the property as open space. Under the concept, the existing pond would be enlarged for stormwater detention, and an additional stormwater detention pond would be constructed near the southwest corner.¹

¹ The site plan shown in Figure 2 is conceptual and developed without City input as part of the RFP process; therefore, the actual development plan may differ significantly from the concept.

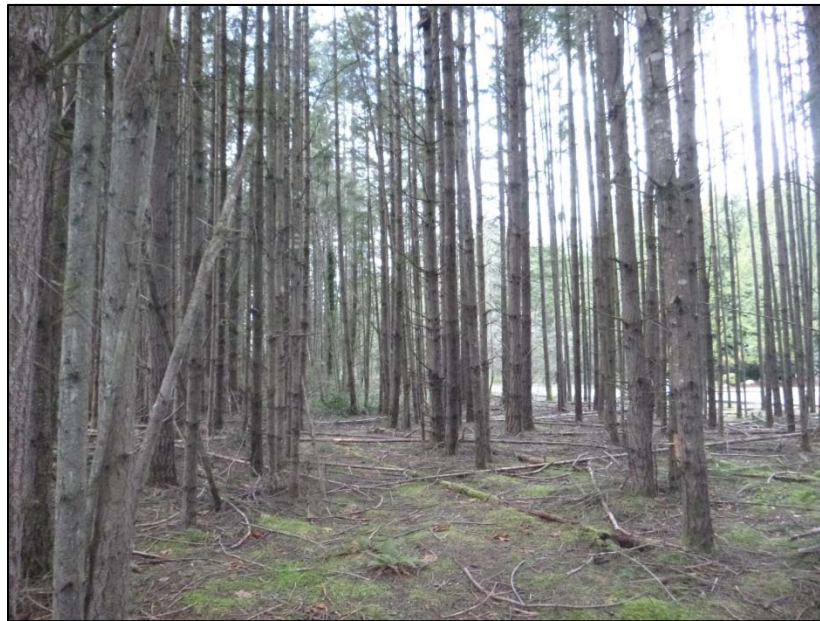
Closed Canopy Forest Zone

The closed canopy forest zone is approximately 3.9 acres in area, and is located along the northern boundary of the property. The zone consists primarily of young Douglas fir trees. Based upon the relatively small size of the trees, the homogenous canopy structures, and the absence of snags and coarse woody debris (e.g. downed trees and logs), it appears that this section of the property was historically cleared and later planted with Douglas fir (likely in the late 20th century). The trees are dense and there are very few gaps in the canopy, which limits understory sapling and shrub vegetation. The understory vegetation that is present consists of trailing blackberry, sword fern, salal, salmon berry, and evergreen huckleberry. The closed canopy forest zone on the property is approximately 3.9 acres in area.

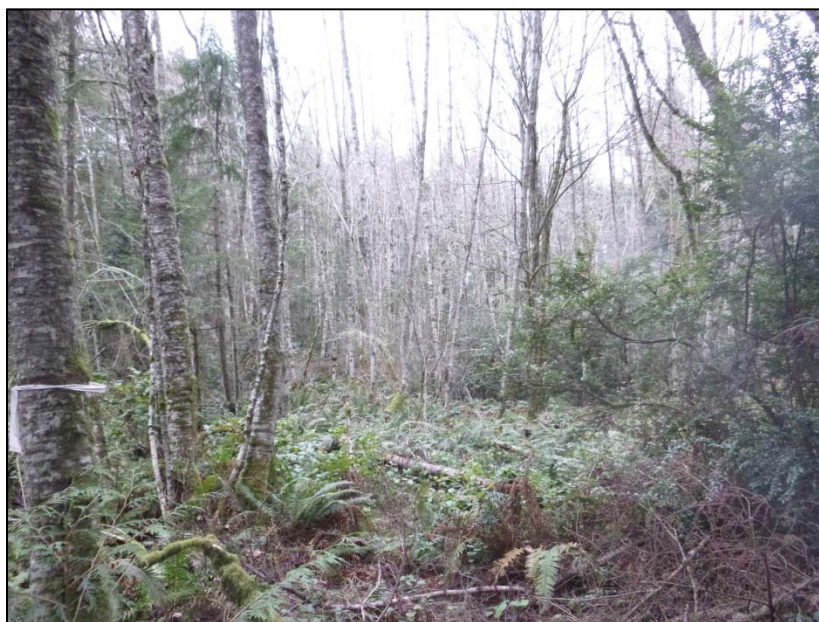
Early Successional Forest Zone

Three areas of early-successional forest are found on the property; a patch near the center of the property, an area around the pond perimeter, and another area along the western property boundary. The total coverage of this forest zone on the property is approximately 2.9 acres. Trees observed in this forest zone include red alder, Big leaf maple, bitter cherry, and Pacific madrone. The dominant tree species in this zone is red alder, a relatively short-lived and fast-growing tree. Some scattered conifer trees (primarily Western red cedar and Douglas fir) are present in this zone, but they appear to be outcompeted by the fast-growing alder and understory shrubs. Dominant understory vegetation in this zone consists of salmonberry, sword fern, and Pacific willow, with invasive Himalayan blackberry observed in some areas, particularly where sunlight is available. Some areas, particularly where canopy gaps are present, contain very dense coverage of understory shrubs. The early-successional forest zone contains a generally low density of snags and coarse woody debris.

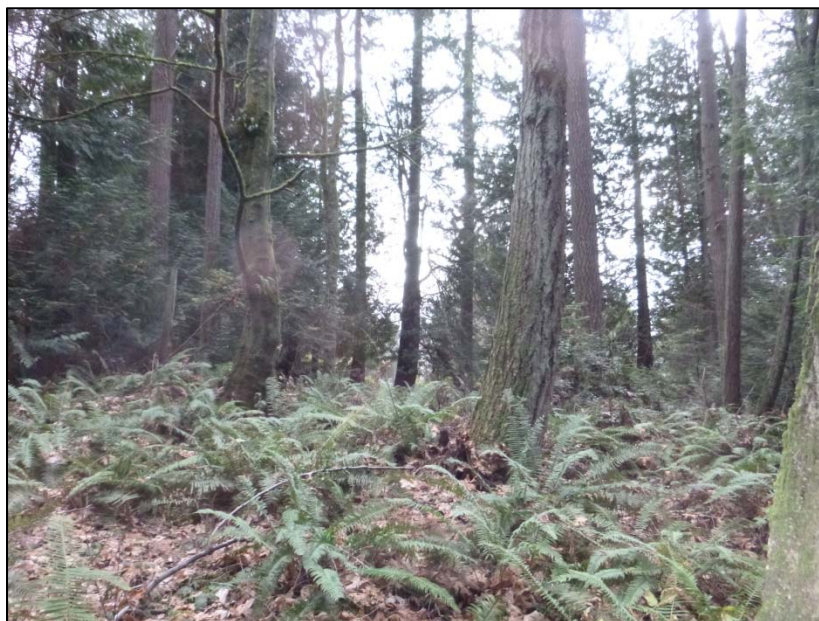
Mid-Successional Forest Zone

The mid-successional forest zone is the predominant forest type on the property; it covers an area of approximately 4.8 acres. This forest type consists of a multi-tiered forest that contains both coniferous trees. There are a moderate amount of canopy gaps in this forest type, which allows for sapling regeneration (primarily western redcedar). The forest appears to be transitioning from a mainly deciduous forest stand to a coniferous forest. Based upon the tree coring results, the age range of trees in this area are between 63 and 67 years old. The dominant tree species in this forest cover type include western redcedar, bigleaf maple, Douglas fir, red alder, and western hemlock. Dominant understory vegetation includes vine maple, evergreen huckleberry, red huckleberry, salal, sword fern, and trailing blackberry. The mid-successional forest zone contains a generally low density of snags, and a moderate density of coarse woody debris.

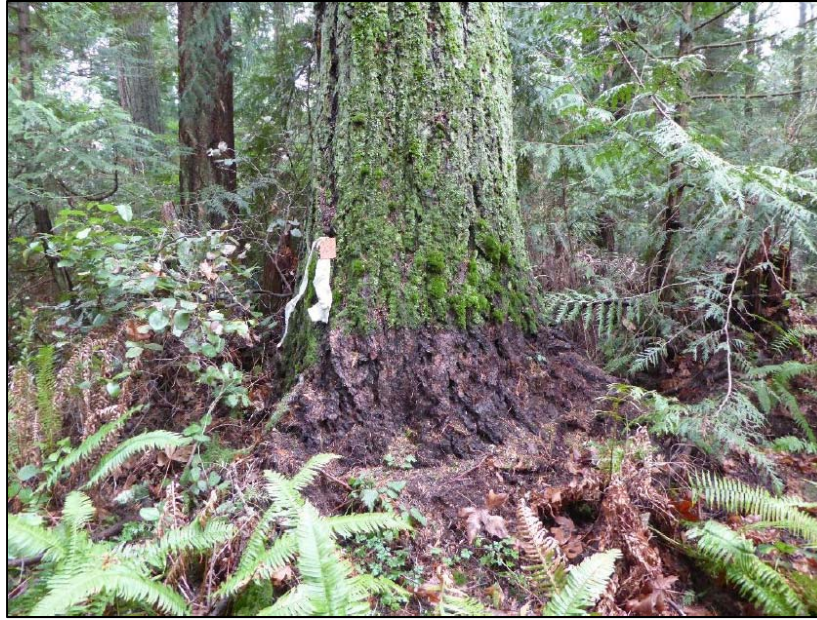
Mature Second-Growth Forest Zone

The southeastern portion of the property is comprised of a mature second-growth forest, which covers of approximately 1.9 acres. Forest characteristics include moderate to large-diameter conifer trees and a multi-layered canopy with shade tolerant shrub species. Tree species observed in this zone are Douglas fir, western redcedar, big leaf maple, western hemlock, and bitter cherry. Dominant understory species include vine maple, evergreen huckleberry, red huckleberry, salal, sword fern, Oregon grape, and trailing blackberry. A moderate volume of coarse woody debris is present on the forest floor, a low density of standing snags was observed.

Based upon the tree coring results, the age range of trees within this forest zone are between 81 to 144 years old. As indicated by the stumps present throughout the property, which show evidence of logging by both crosscut saw and chainsaws, it is likely that this area was logged in multiple events. Based upon historical records of logging, the first major logging event likely occurred in the 1870s.

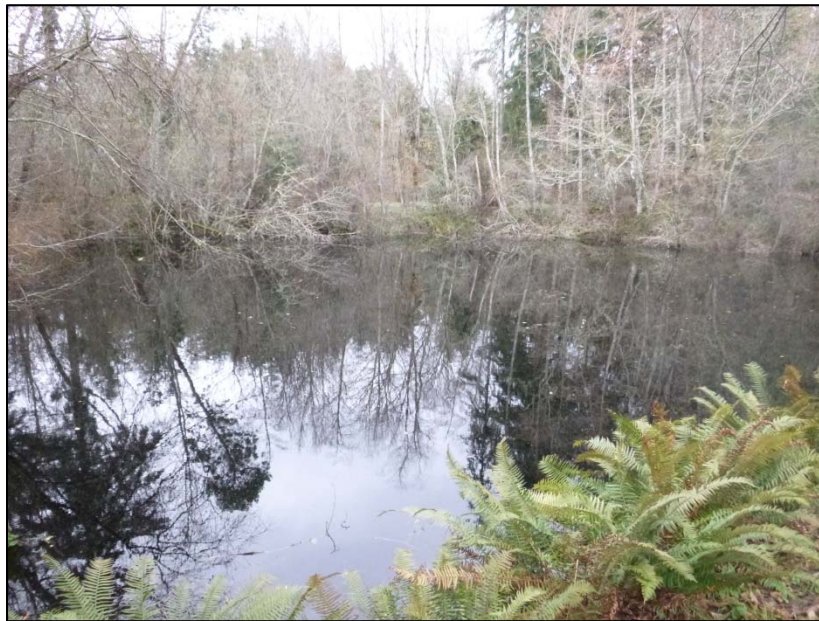
Human-Created Pond

As shown in Figure 3, an approximately 0.25-acre human-created pond is located near the southern property boundary. The pond is surrounded by an earthen berm, and is likely maintained by a high groundwater table and/or a clay lining at the bottom of the pond. Douglas fir tree rooted within the berm was determined to be between 71 and 76 years old (see Appendix A for details), which indicates that the pond was likely constructed in the mid-20th century.

The pond is permanently flooded and approximately 10 feet deep, with a seasonal variation of 3 to 4 feet (Bainbridge Island, 2016). Vegetation observed in the pond includes duckweed, water parsley, and yellow-flag iris. Despite the fact that the pond is a human-made feature, it provides habitat for a wide variety of species that rely on open water habitat for all or a portion of their life cycle, such as amphibians and many insects (Sheldon, et al., 2005). Other species use open water areas for obtaining some life requirements (e.g. sources of prey and drinking water), such as deer and herons. The close proximity and uninterrupted connection between the pond and the adjacent forest habitat support both the overall wildlife populations and biodiversity found on the property.

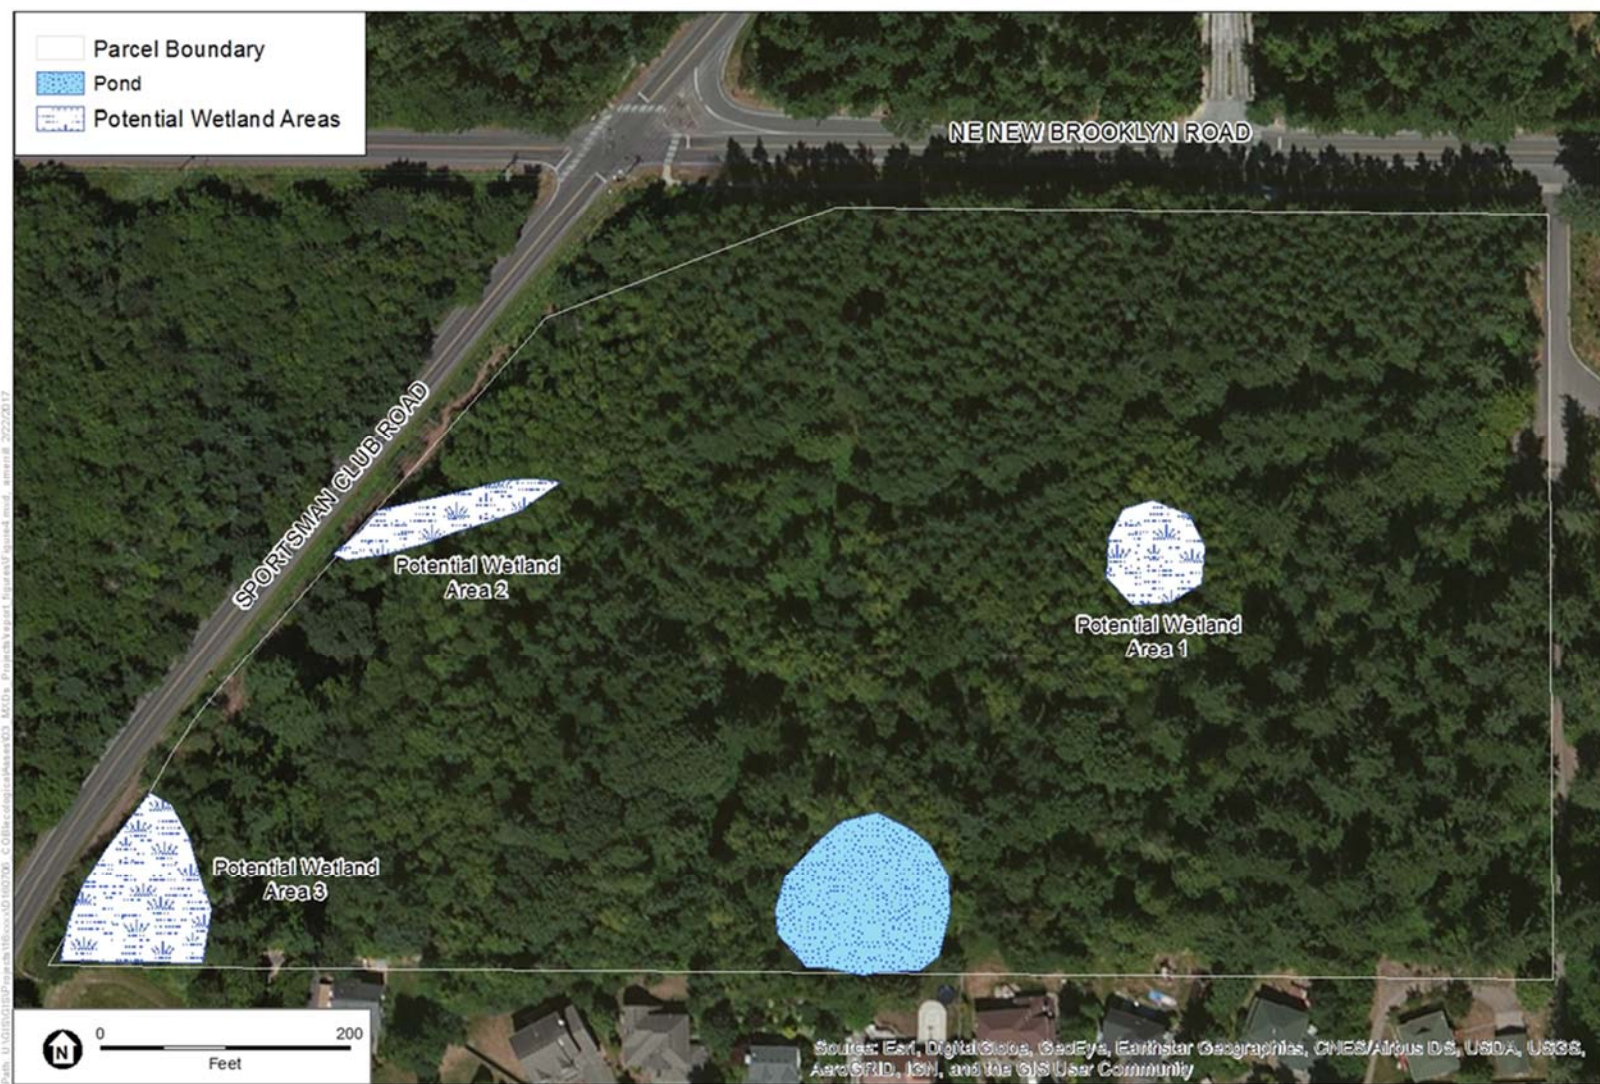
Figure 4
Potential Wetland Areas

Along with the pond, three potential wetland areas were identified on the property, which are shown in Figure 4 and described below. Wetlands provide many valuable environmental functions, such as water quality improvement, flood water storage, and habitat for plants and animals (Sheldon, et al., 2005). The ability of a wetland to provide these functions is dependent upon a variety of factors, such as the wetland's topography and position in the landscape, water regime, proximity to adjacent habitats, and vegetative composition.

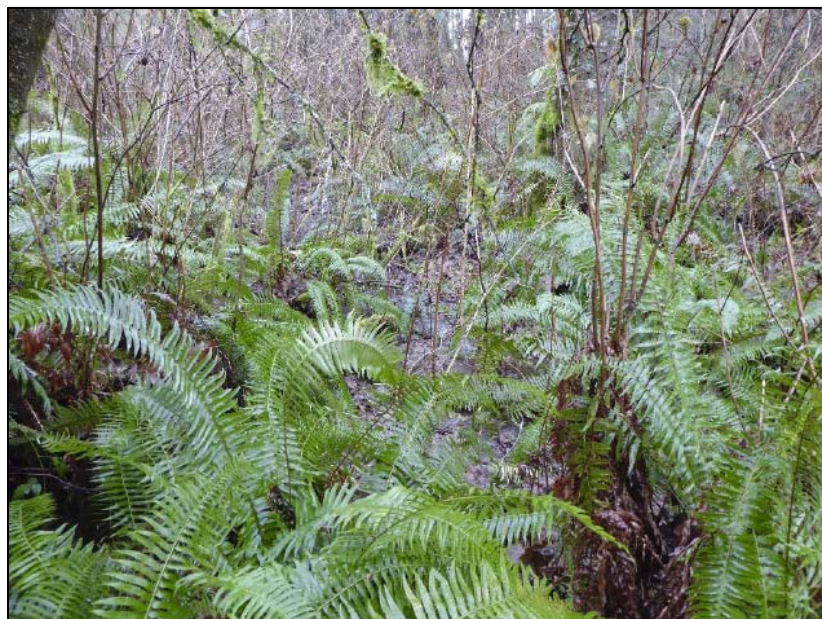
Potential Wetland Area 1 is a depressional feature located near the center of the property. The dominant vegetation in the area is primarily red alder trees, with some scattered western red cedar trees. The understory is dominated by salmonberry, with patches of salal, sword fern, and trailing blackberry, primarily on the fringes of the wetland area.

During the December 15, 2016 site visit, shallow ponded water was observed in the middle of the potential wetland area. The area is isolated (i.e. there is no obvious surface water outlet).

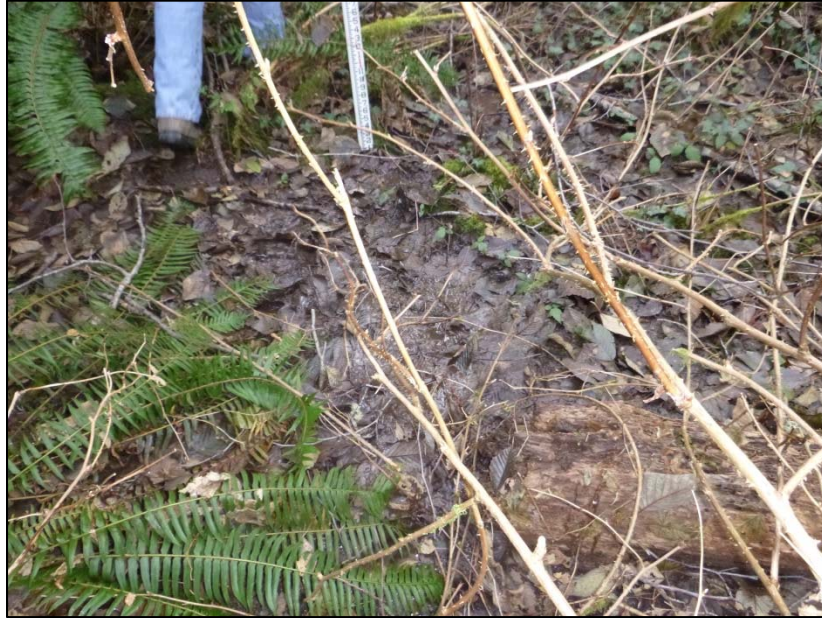
Potential Wetland Area 2 is a linear swale feature located in the east-central portion of the property. The area slopes to the west, and drains into the ditch along Sportsman Club Road (see Section 3.3.5). The dominant vegetation in the area is primarily red alder trees with an understory of salmon berry, with some scattered patches of sword fern, trailing blackberry, and red elderberry along the wetland area boundary. During the December 15, 2016 site visit, areas of soil saturation and water seeping from the hillside were observed.

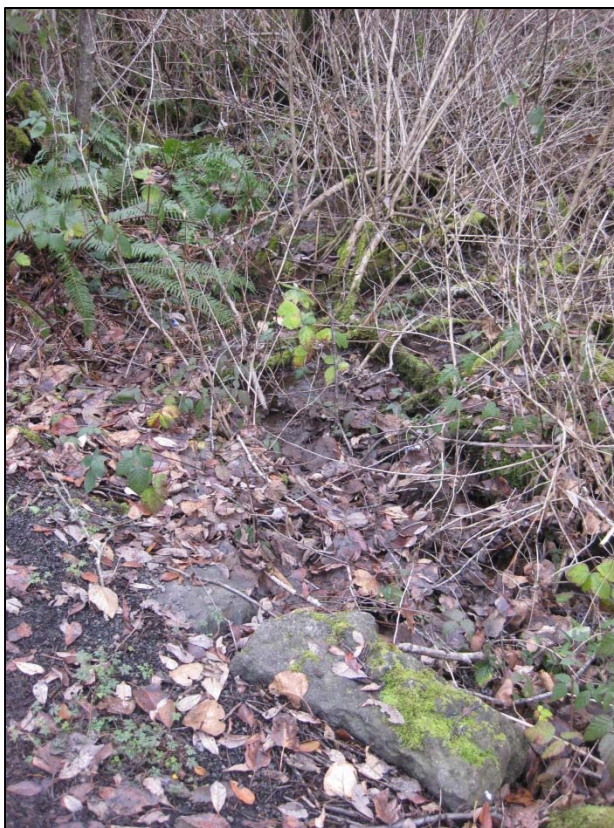
Potential Wetland Area 3 is a depressional feature located near the southwest corner of the property. The area drains southward into the ditch along Sportsman Club Road (see Section 3.3.5). The dominant vegetation in the area is primarily red alder trees and mature willows, with an understory of salmonberry and soft rush. During the December 15, 2016 site visit, ponding was observed in the area, and water was observed flowing out of the area into the adjacent ditch.

It appears that a portion of the wetland is seasonally flooded (meaning that the observed ponding persists for at least two consecutive months out of the year). Therefore, as opposed to the other two potential wetland areas identified on the property, Potential Wetland Area 3 may provide breeding habitat for amphibians.

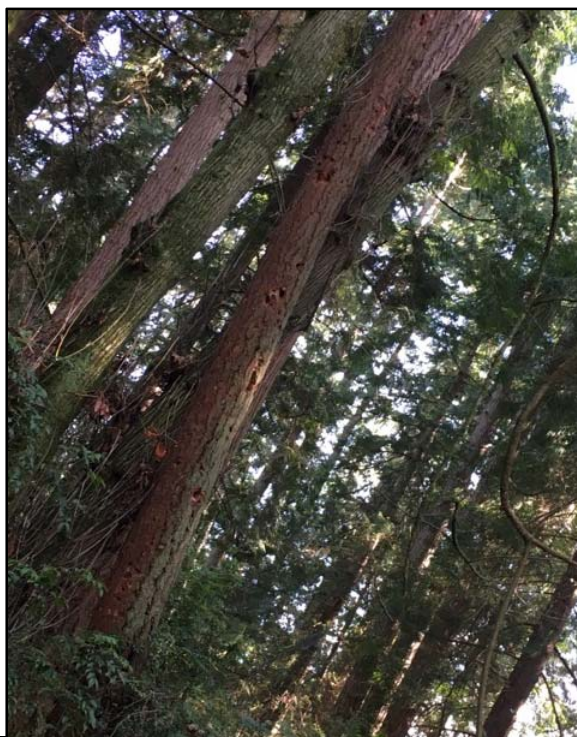
Snag with cavities observed in the southeastern portion of the property (Photo courtesy L. Marshall)

Pileated woodpecker generally nest in snag cavities or in the dead branches of live trees, usually 15 to 80 feet above ground (Audubon Society, 2017). Snag cavities that may provide nesting sites for pileated woodpecker were observed on the property; however, no nests have been observed to date. If present, the nests would likely occur in the mid-successional forest zone (Type 3) or the mature second-growth forest zone (Type 4), as suitable nesting snags were not observed in the other forest zones. WDFW PHS data (2017a) shows the nearest documented pileated woodpecker nesting habitat is located approximately 2 miles west of the property, near the corner of NE Tolo Road and NE

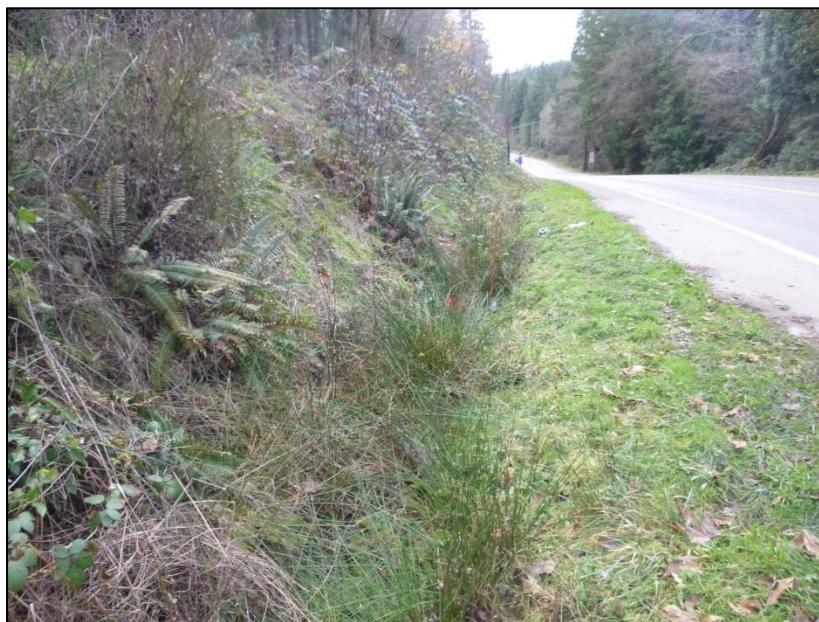
In the immediate vicinity of the property, the drainage feature appears to be a human-created ditch with a primary purpose of intercepting and conveying stormwater runoff from Sportsman Club Road. The channel is heavily vegetated with blackberry, rushes, grasses and forbs forming a thick mat of vegetation within the bottom and sides of the channel. Patches of swordfern, an upland plant, also extend adjacent and into the channel. The substrate within the soil is predominantly compacted organic soil and root material, with little natural cobble or gravel observed (some irregular and small patches of angular quarry spalls were observed).

Drainage ditch west of the Suzuki Property

Based on the observed channel, habitat, and hydrology within the drainage feature, it appears that the portion of the drainage feature within the immediate vicinity of the property should not be considered a stream, but rather a manmade stormwater conveyance feature. Drainage appears to come primarily from roadway stormwater runoff and no suitable habitat for fish species is present within the homogenous, linear channel. Downstream of the property, it is likely that the contributing basin area is large enough to create and maintain a stream channel, but these conditions do not occur within the immediate vicinity of the property.
