September 12, 2018

Re: Suzuki property preliminary tree assessment, Bainbridge Island, WA

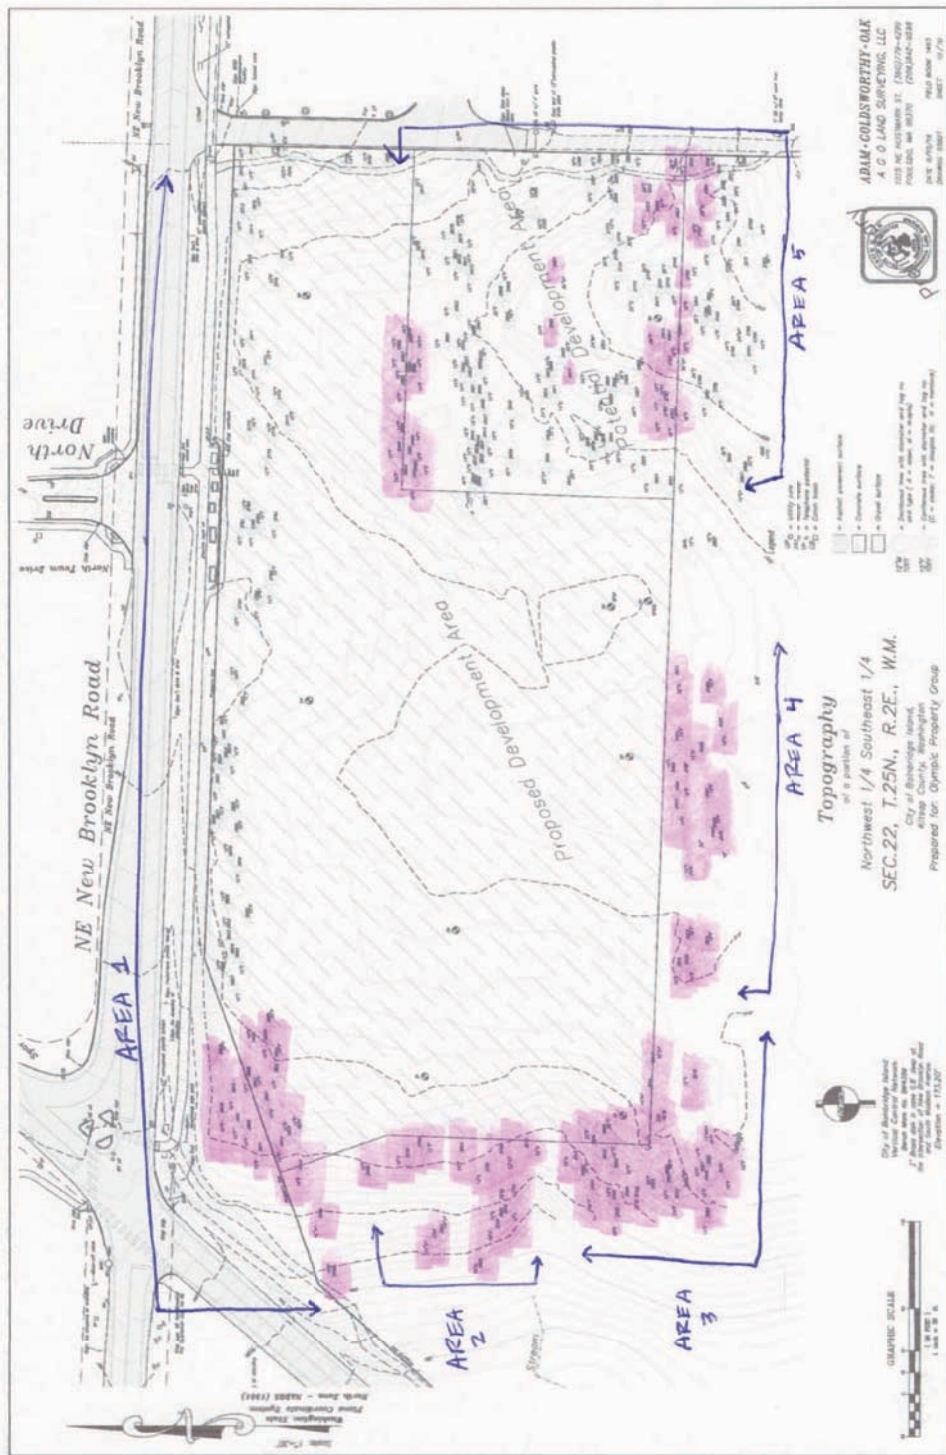
MAP 1 Suzuki prelim tree assessment.
9/12/18

Several maps are included in this report. Map 1 locates the trees that were specifically assessed and have complete data regarding their condition, structures, overall vigor and recommendations.
